## Sunnyside Cogeneration Associates

RE: Annual 2005 Inspection Report  
Star Point Refuse Pile C/007/042

<b>IMPOUNDMENT INSPECTION AND CERTIFIED REPORT</b>		Sediment Pond 005	
<b>Permit Number</b>	C/007/042	<b>Report Date</b>	1/20/06
<b>Mine Name</b>	STAR POINT WASTE FUEL		
<b>Company Name</b>	SUNNYSIDE COGENERATION ASSOCIATES		
<b>Impoundment Identification</b>	<b>Impoundment Name</b>	Sediment Pond 005	
	<b>Impoundment Number</b>	005	
	<b>UPDES Permit Number</b>	UTG040025	
	<b>MSHA ID Number</b>	N/A	
<b>IMPOUNDMENT INSPECTION</b>			
<b>Inspection Date</b>	December 14, 2005		
<b>Inspected By</b>	Rusty Netz		
<b>Reason for Inspection</b> (Annual, Quarterly or Other Periodic Inspection, Critical Installation, or Completion of Construction)		Annual Inspection 2005	
<p><b>1. Describe any appearance of any instability, structural weakness, or any other hazardous condition.</b></p> <p>NONE</p>			
<b>Required for an impoundment which functions as a SEDIMENTATION POND.</b>	<p><b>2. Sediment storage capacity, including elevation of 60% and 100% sediment storage volumes, and, estimated average elevation of existing sediment.</b></p> <p>Total Pond volume = 6.96 acre-feet</p> <p>Sediment St

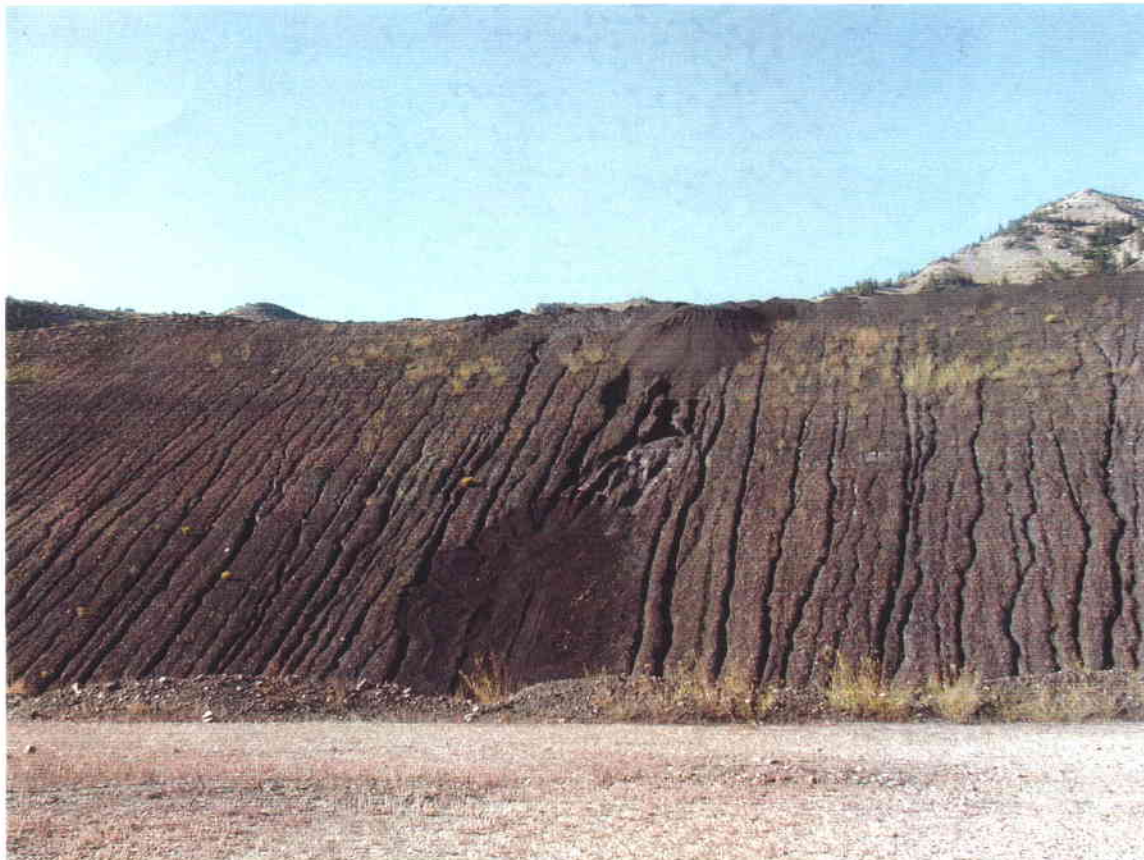
Storms during the Third Quarter 2005 caused noticeable erosion on the site and interim catchment areas had collected a lot of sediment. SCA cleaned these areas and restored the eroded areas.

East Face Refuse Pile A – Eroded area with restoration efforts underway Sept 20, 2005

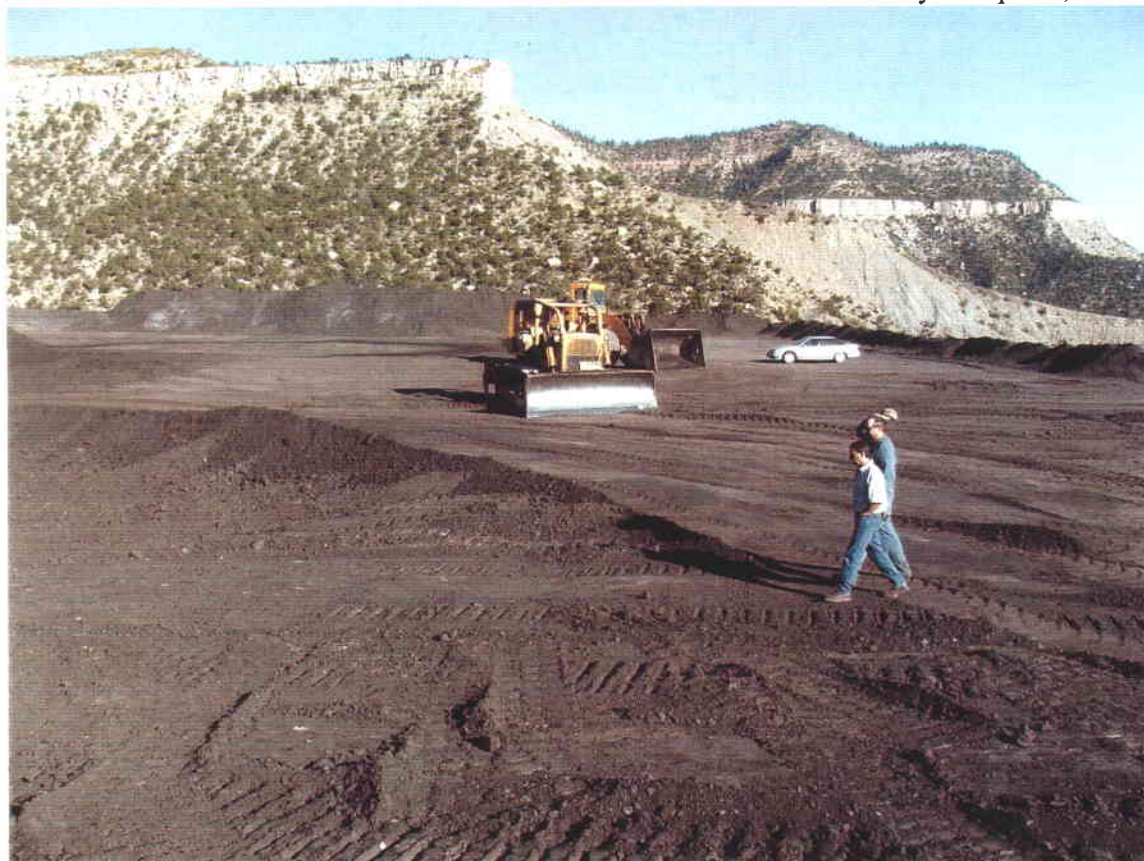
Excavation and hauling operations are occurring from the top of the pile

Top East End Refuse Pile Looking northerly
